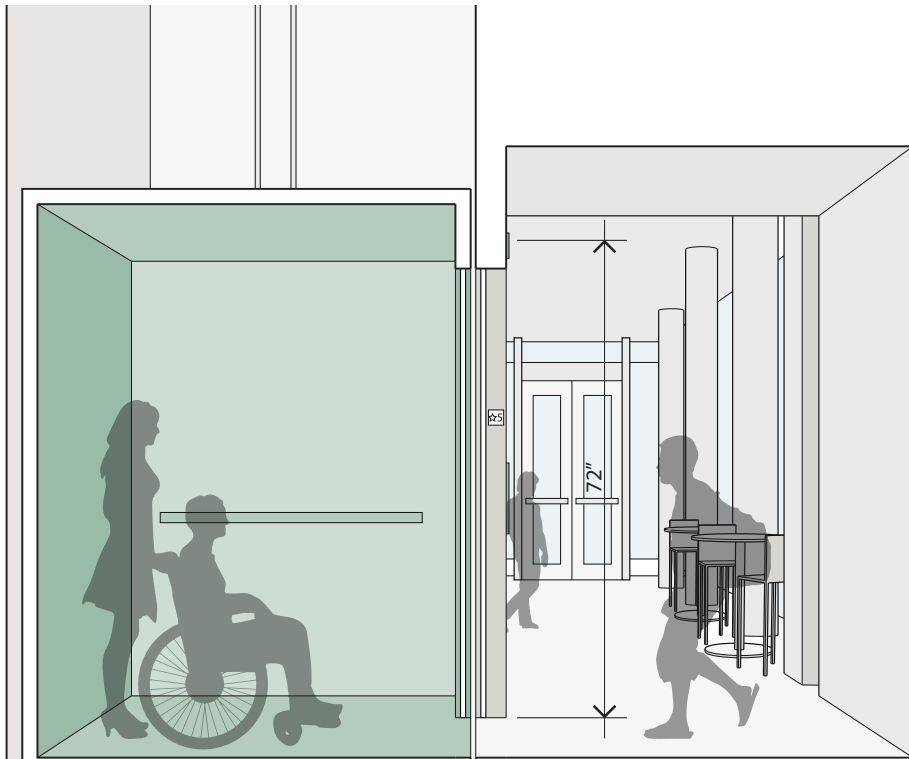
Diagram: Elevator

a car call for 3 seconds minimum, we found that these three seconds were not enough time for someone in the wheelchair to get out of the elevator and into the hallway, or vice versa. We had a huge issue with the elevator door closing on the wheelchair. This was especially an issue when allowing a large group of people out of the elevator first.

The elevator provided near the café complies with all of the ADA rules for elevators. For example, the visible signals (407.2.2.2) above the entrances are at least 72", the hoistway signs that provide floor destination (407.2.3.1) are at least 2" in height, and the elevators' dimensions (407.4.1) all exceed the width requirements for a standard wheelchair accessible elevator. Although the elevator also complies with Section 407.3.5: Elevator doors shall remain fully open in response to

SUGGESTION:

Increase the amount of time the elevator stays open, since 3 seconds is not enough time for a disabled/differently person to comfortably exit the elevator.

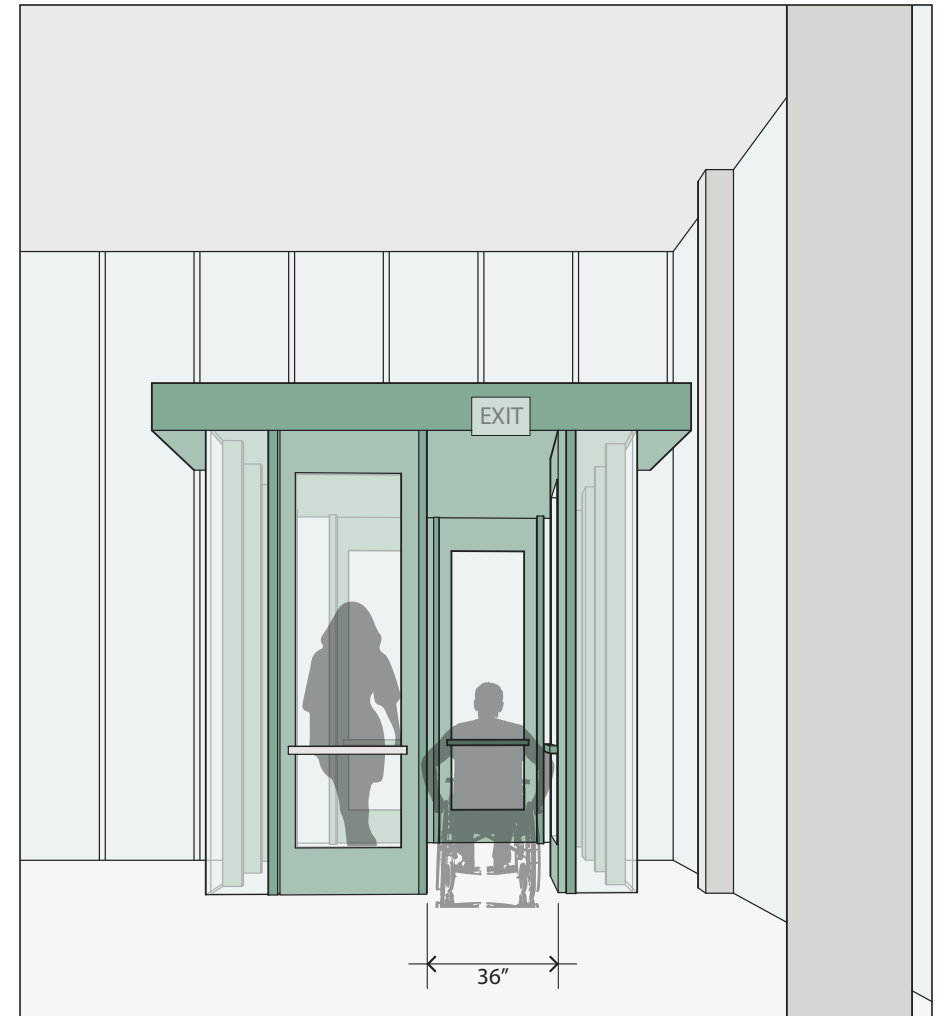
Diagram: Exit to Newell Simon Hall

The exit to the back of Newell Simon Hall is the main exit of this floor and is formed from double doors in the corner of the café. Each single door measures 36" across and follows ADA's Section 404.2.3 Clear Width, which states that door openings shall provide a clear width of 32." Regardless of the ADA code, we discovered from experience that this standard door size is still concerning for

those who are disabled, since squeezing through this doorway risks arm and finger injuries if one is not careful.

SUGGESTION:

Enlarge the width of exit doors to the outside, to reduce the risk of harm to limbs.
